# Roadway Geotechnical Engineering Report

Grand Avenue Frontage Road Improvements  
US 60 – Greenway Road to Thompson Ranch TI  
El Mirage, Arizona

ADOT Tracs No. 060 MA 145 H8874 01D

Terracon Project No. 65165128

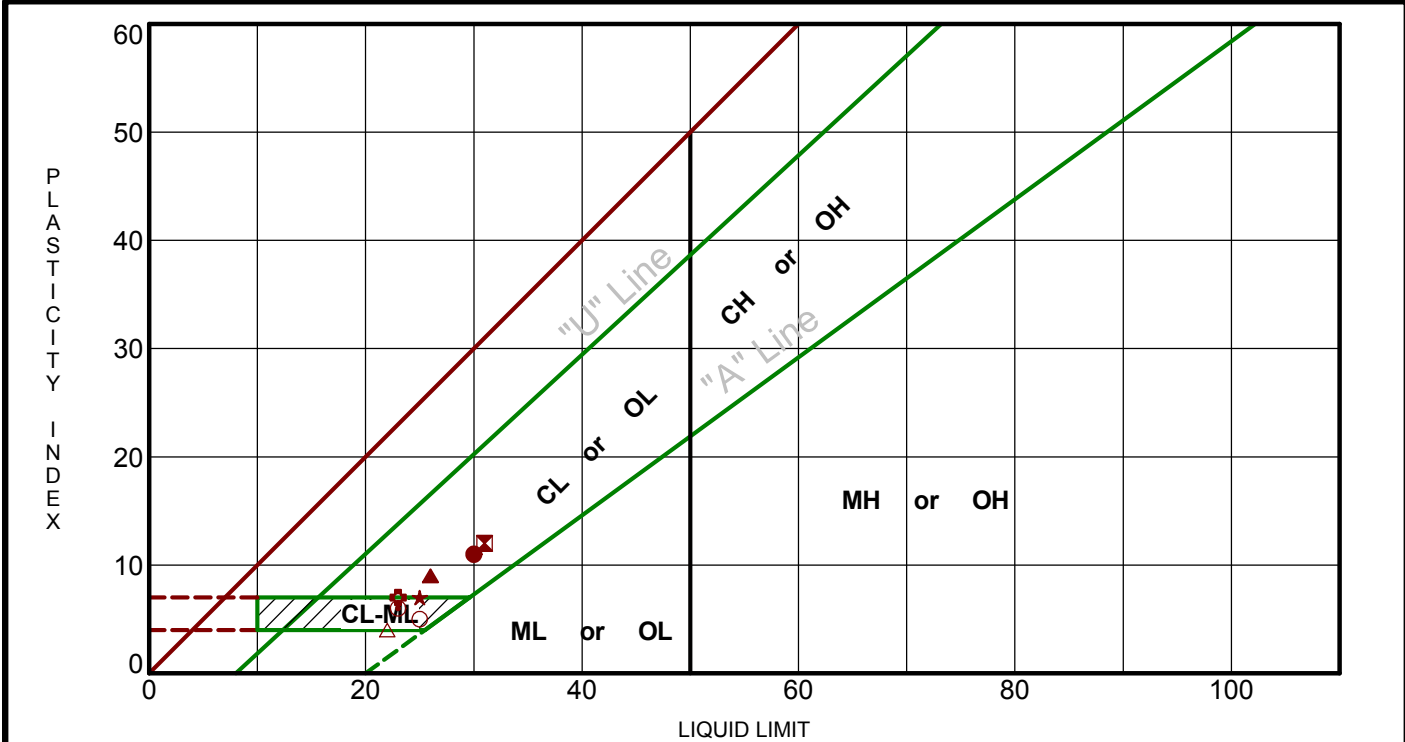
# ATTERBERG LIMITS RESULTS

Boring ID	Depth	LL	PL	PI	Fines	USCS	Description
● B-1	1 - 4	30	19	11	47	SC	CLAYEY SAND
⊠ B-2	1 - 3.5	31	19	12	8	GP-GC	POORLY GRADED GRAVEL with CLAY and SAND
▲ B-3	1 - 2	26	17	9	26	SC	CLAYEY SAND with GRAVEL
★ B-4	1.5 - 4	25	18	7	41	SC-SM	SILTY, CLAYEY SAND
⊙ B-5	1 - 4	23	17	6	45	SC-SM	SILTY, CLAYEY SAND
⊕ B-6	2.5 - 5	23	16	7	57	CL-ML	SANDY SILTY CLAY
○ B-7	0.5 - 5	25	20	5	81	CL-ML	SILTY CLAY with SAND
△ B-8	1 - 3	22	18	4	43	SC-SM	SILTY, CLAYEY SAND
